All Island Home Inspections

Property Inspection Report

Inspection prepared for: Sample Report
Date of Inspection: 4/10/2017

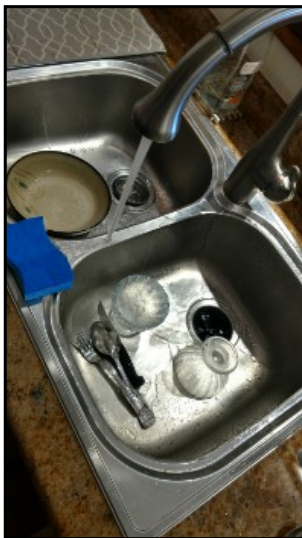
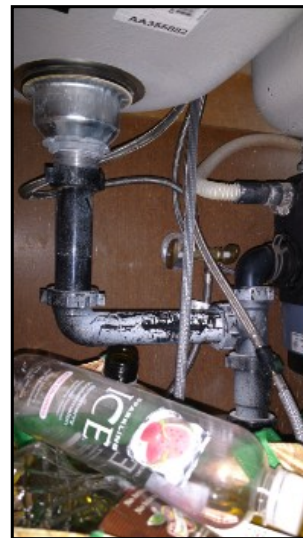
1. Sinks

- Supply valves appear to have been updated from original and in serviceable condition.
- No leaks observed under sink at time of inspection
- No deficiencies observed.

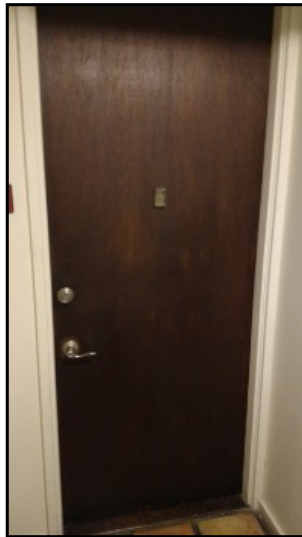
1. Entry Door

- Door appears to be in serviceable condition

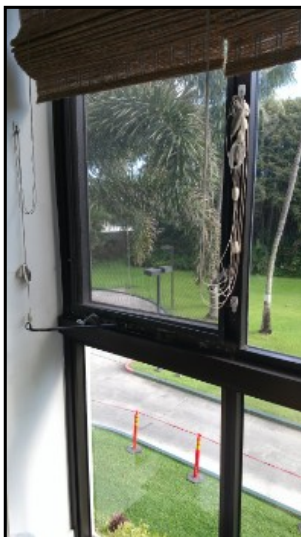
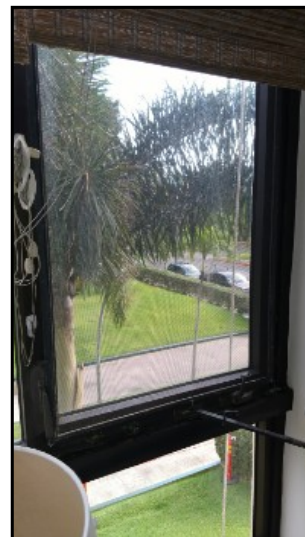
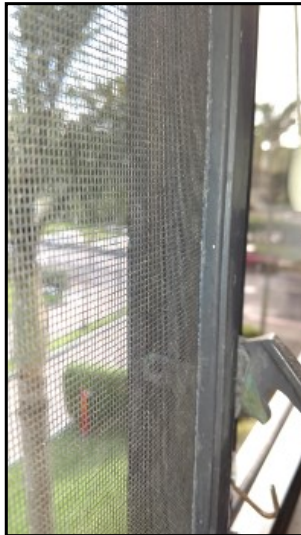
2. Window Condition

- Latch/lock bar is missing at both windows.

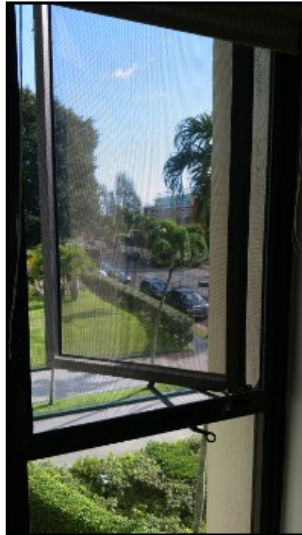
1. Window Condition

- Crank handle has excessive play.
- Latch/lock bar is missing
- Damaged screens observed.

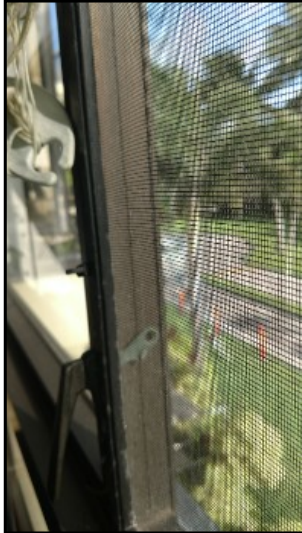
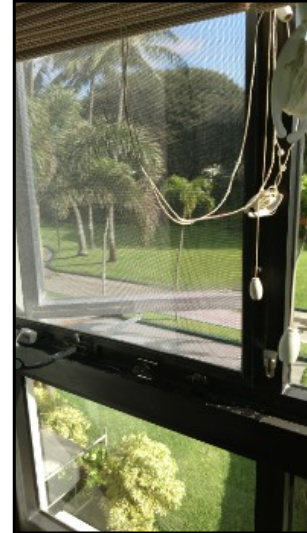
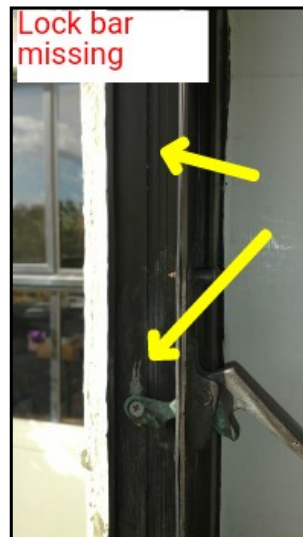
1. Window Condition

- Crank handle has excessive play.
- Latch/lock bar is missing
- Latch/lock handle is damaged/missing.

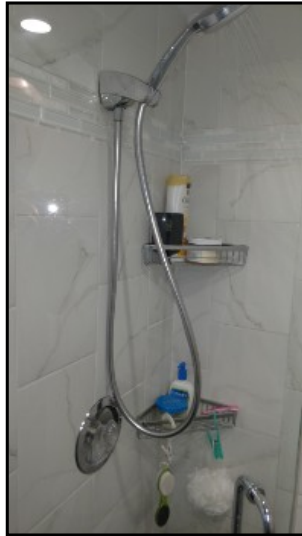
1. Shower faucet

- Shower faucet appears to be in functioning condition.

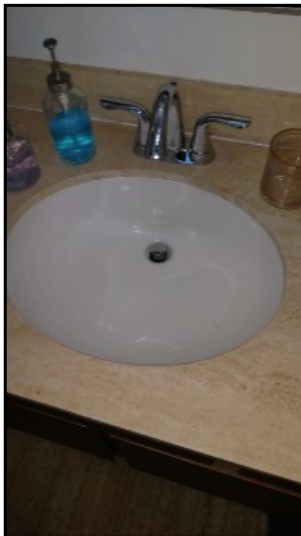
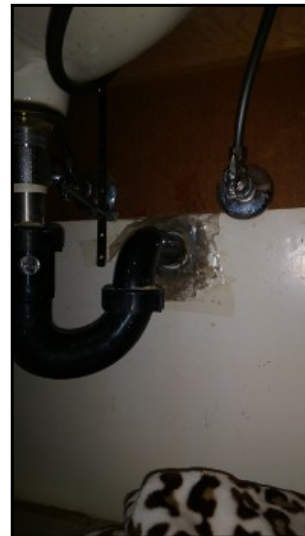
3. Sinks

- Supply valves appear to have been updated from original and in serviceable condition.
- No leaks observed under sink at time of inspection
- No deficiencies observed.

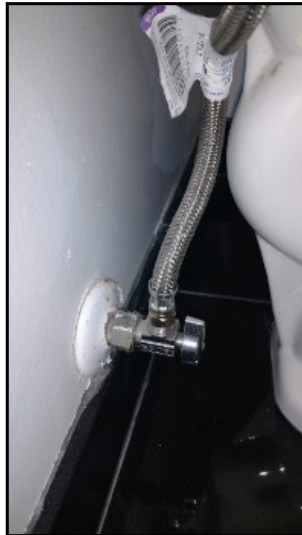
4. Toilets

- Observed as functional and in good visual condition.

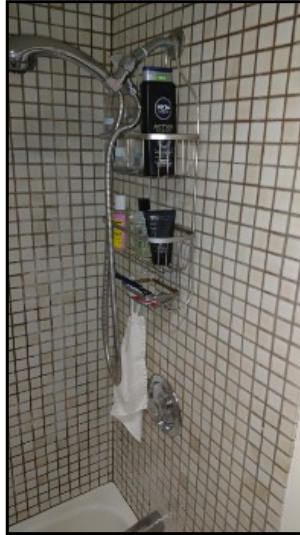
1. Shower faucet

- Shower mast is loose in the wall.
- Faucet is loose in the wall.

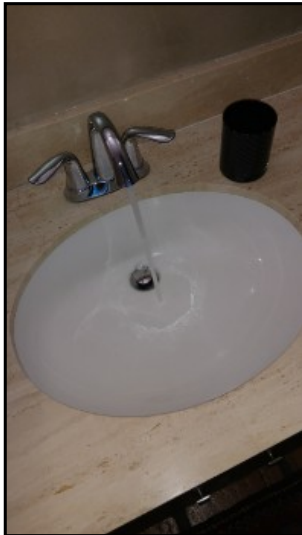
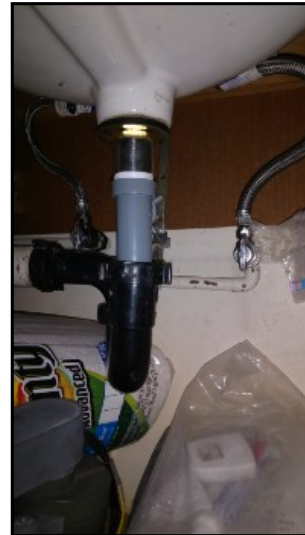
4. Sinks

- Supply valves appear to have been updated from original and in serviceable condition.
- No leaks observed under sink at time of inspection.
- No deficiencies observed.

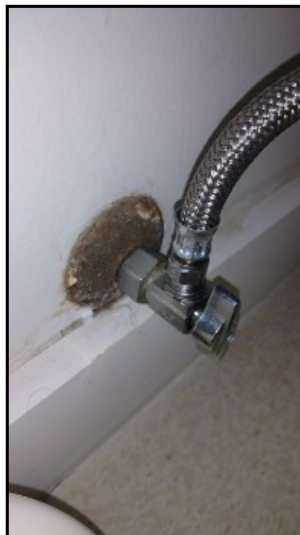
5. Toilets

- Observed as functional and in good visual condition.
- Supply valve appears to have been updated from original and in serviceable condition.

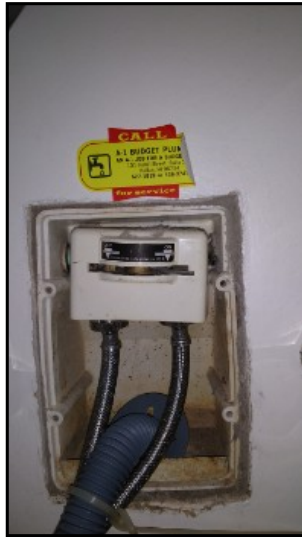
2. Plumbing

- No discrepancies noted.

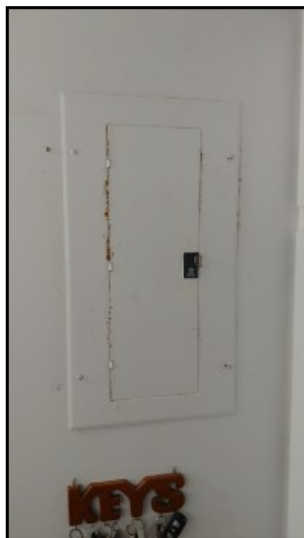
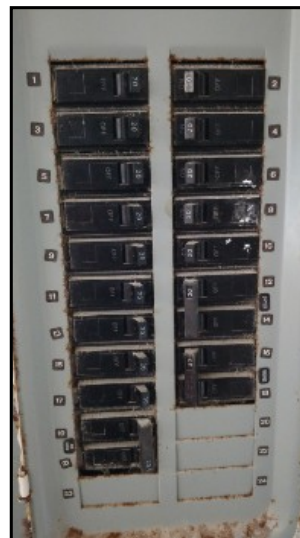
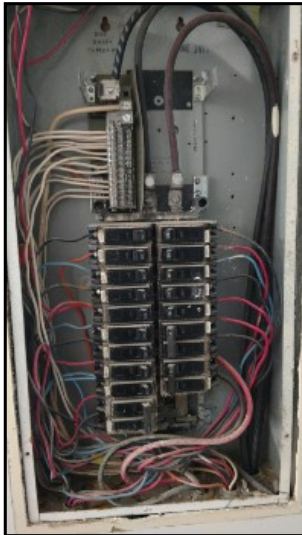
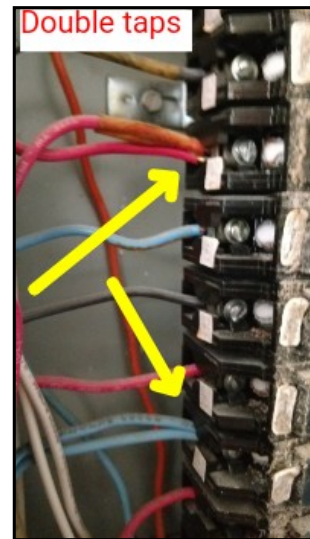
1. Electrical Panel

- Double tapped breaker(s) inside panel box (more than one electrical conductor attached). This is not standard practice, and may cause overheating or even an electrical fire. Recommend evaluation by an electrician. Double tapping and lugging can create hot spots on breakers and neutral bars because they are not tightened to the correct torque--especially if two different size conductors are used. Because the hot [black] and neutral [white] wires are both current carrying conductors, the chance is then greater for potential hot spots. If the **double tap** or lug becomes loose, it begins to arc. As it arcs it builds up carbon. Carbon is then resistance and with more carbon buildup the more difficult it is for the conductor to make contact, thus increasing the current. The end result can be the breaker tripping because of the loose connection [current exceeding the rating of the breaker], or signs of overheating such as discolored wires, melted wires, etc, or even fire.

- Spliced & taped wires.
- Questionable wiring in panel box. Have licensed electrician evaluate.
