All Island Home Inspections

Property Inspection Report

Inspection prepared for: Sample Report
Date of Inspection: 3/13/2017

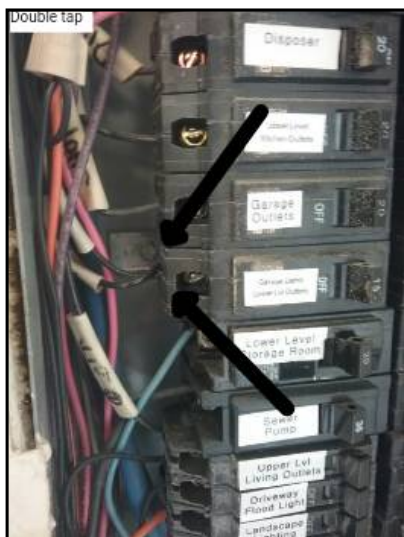
1. Electrical Panel

- Double tapped breaker(s) inside panel box (more than one electrical conductor attached). This is not standard practice, and may cause overheating or even an electrical fire. Recommend evaluation by an electrician. Double tapping and lugging can create hot spots on breakers and neutral bars because they are not tightened to the correct torque--especially if two different size conductors are used. Because the hot [black] and neutral [white]wires are both current carrying conductors, the chance is then greater for potential hot spots. If the **double tap** or lug becomes loose, it begins to arc. As it arcs it builds up carbon. Carbon is then resistance and with more carbon buildup the more difficult it is for the conductor to make contact, thus increasing the current. The end result can be the breaker tripping because of the loose connection [current exceeding the rating of the breaker], or signs of overheating such as discolored wires, melted wires, etc, or even fire.

- Bushings missing from around branch wire(s) entering panel box.
- Breaker #6(unnamed) appears to be overheating and should be replaced and circuit checked for proper wiring by a licensed electrician,

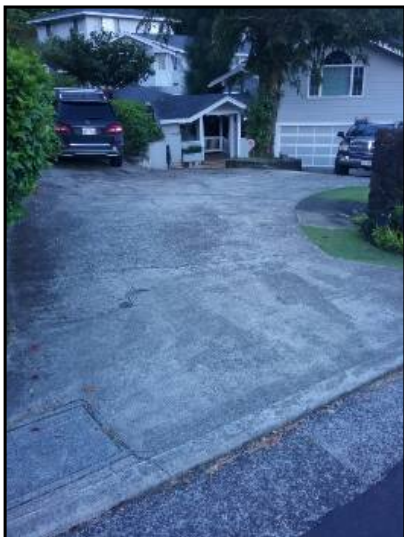
1. Driveway and Walkway Condition

- Driveway improperly sloped towards the garage/Recommend slab jacking, repair or replacing the settled concrete.

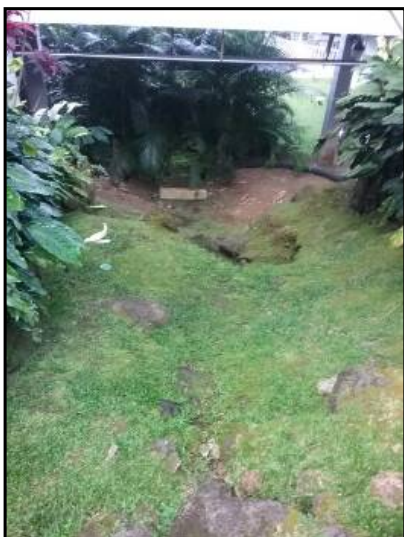
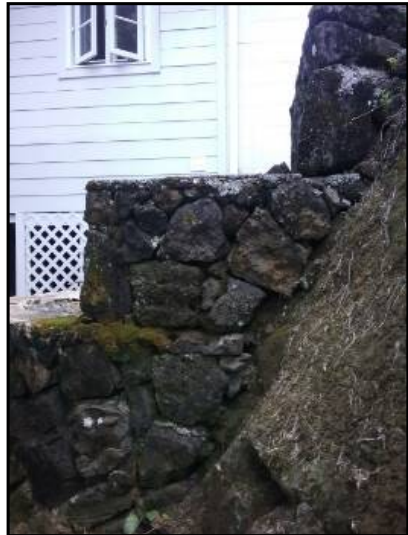
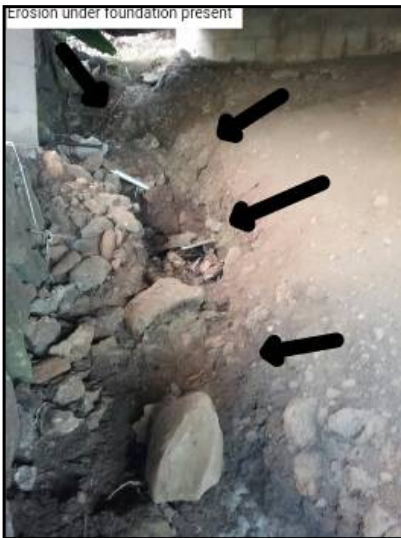
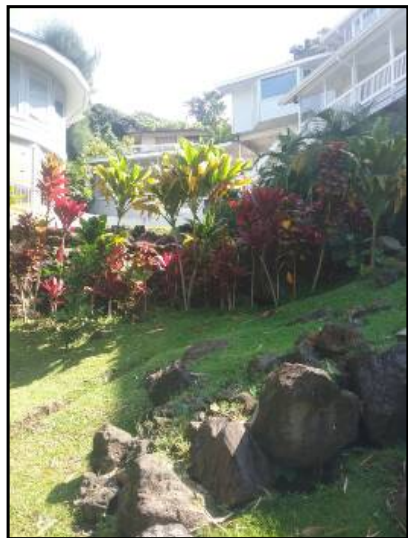
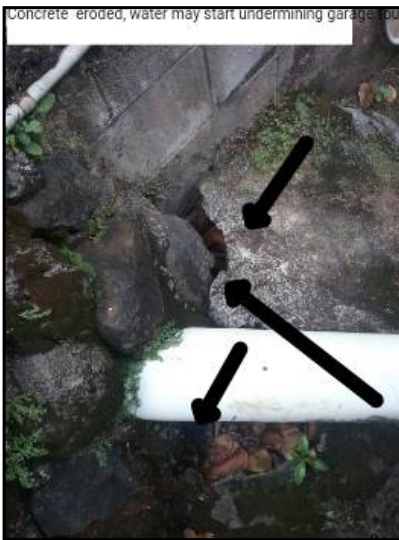
2. Grading

- Lot grading and drainage have a significant impact on the building, simply because of the direct and indirect damage that moisture can have on the foundation. It is very important, therefore, that surface runoff water be adequately diverted away from the home. Lot grading should slope away and fall a minimum of one (1) inch every foot for a distance of six (6) feet around the perimeter of the building.
- The exterior grading is improperly sloped towards the foundation. Water can intrude into the interior. Recommend creating the proper slope away from the foundation to allow for proper drainage.
- Retaining Wall shows signs of deterioration.

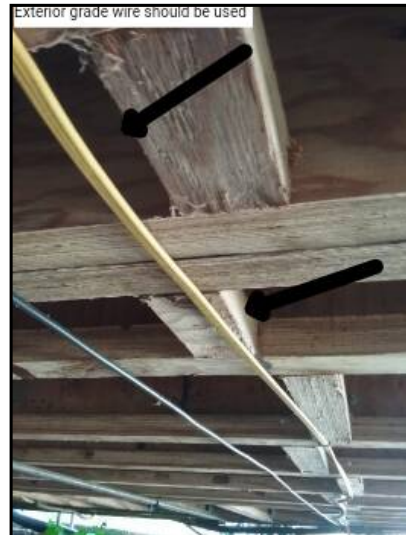
6. Grounds Electrical

- Interior grade Romex should be replaced with exterior-rated Romex and enclosed in conduit.

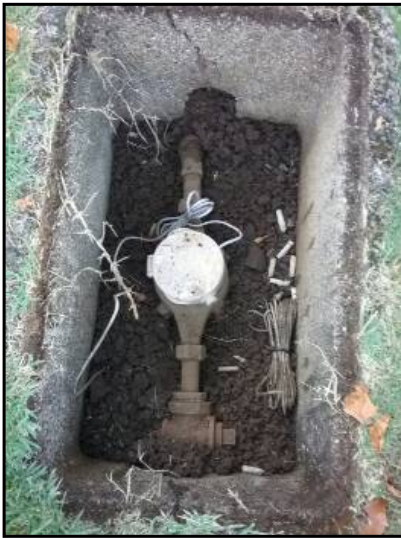
9. Plumbing

- Corrosion is noted. Consult with a licensed plumbing contractor to determine and correct the cause of the issue.

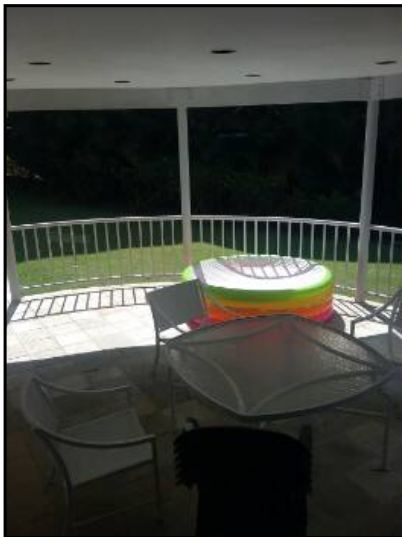
14. Lanai Enclosure

- Appears in satisfactory and functional condition with normal wear for its age. Appears to be sound structure.
- Improve: Typical cracking was observed at the concrete surfaces. Recommend sealing the cracks to prolong the life of the concrete.

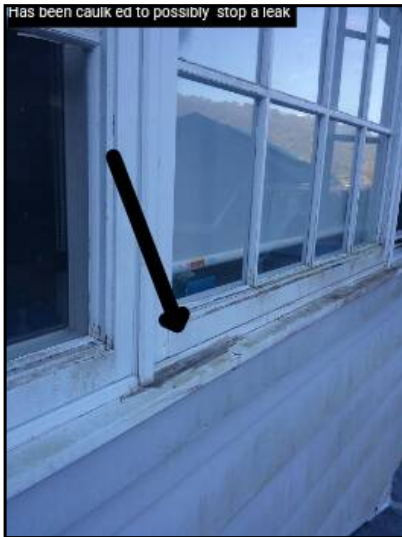
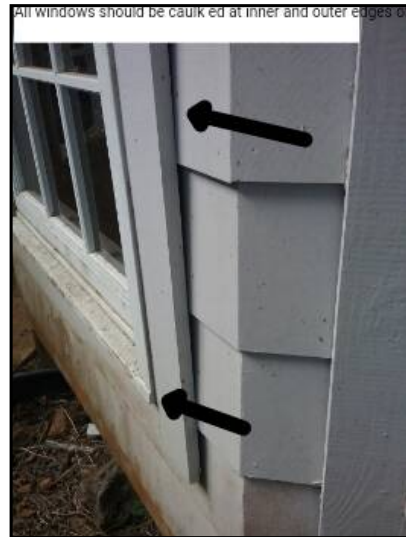
2. Window Condition

- Deteriorated frame(s) at window(s)

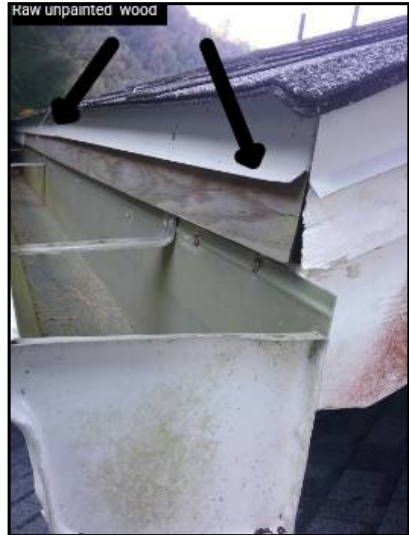
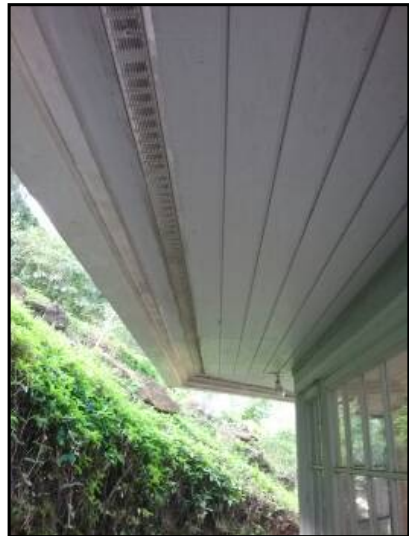
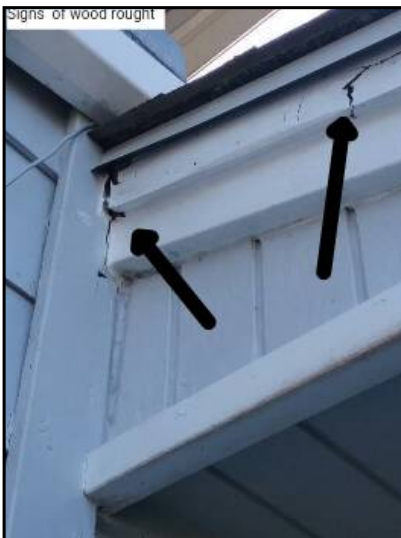
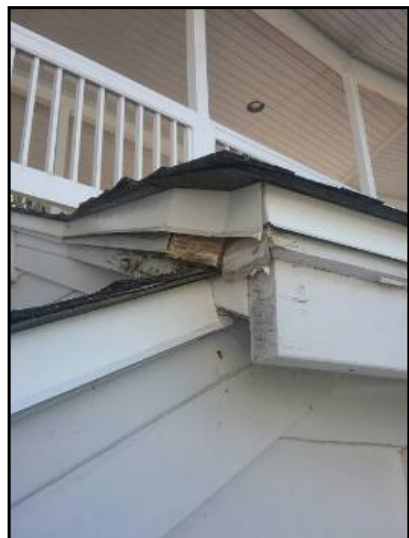
4. Eaves & Facia

- Soffits at the home appeared to be in serviceable condition at the time of the inspection.
- Suggest sealing/caulking as part of routine maintenance to prevent further deterioration.

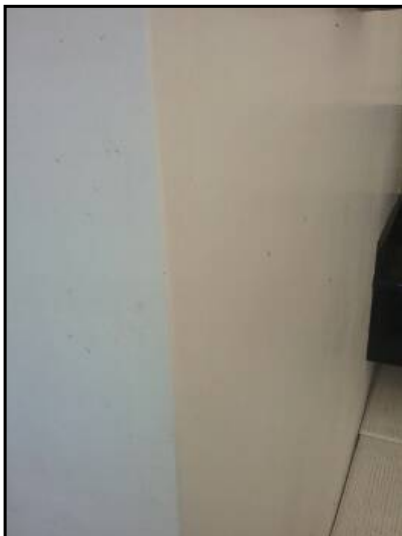
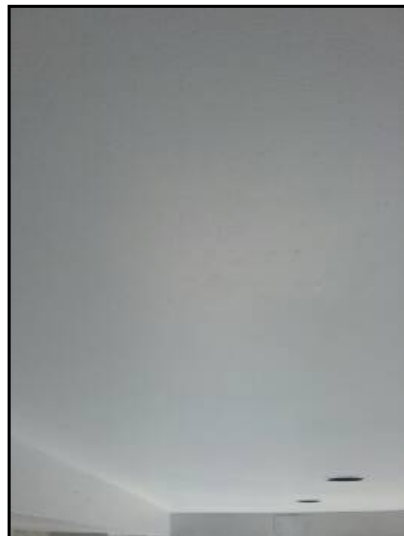
5. Exterior Paint

- Suggest sealing/caulking as part of routine maintenance to prevent further deterioration.
- Peeling paint observed, suggest scraping and painting as necessary.
- Exposed wood surfaces observed. Wood rot & deterioration can occur. Prep, prime and paint wood trim surface where paint is peeling or missing.
- All exterior painted wood trim surfaces should be annually examined and sealed, re-caulked and re-painted as needed.

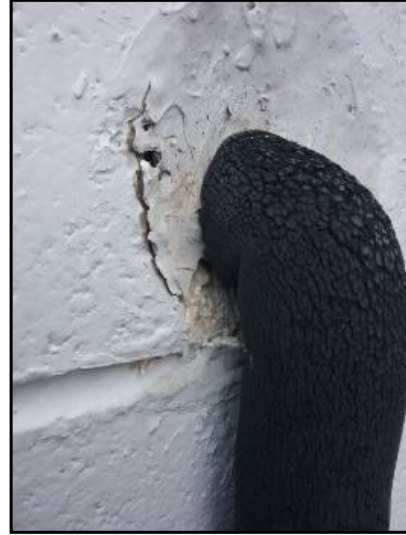
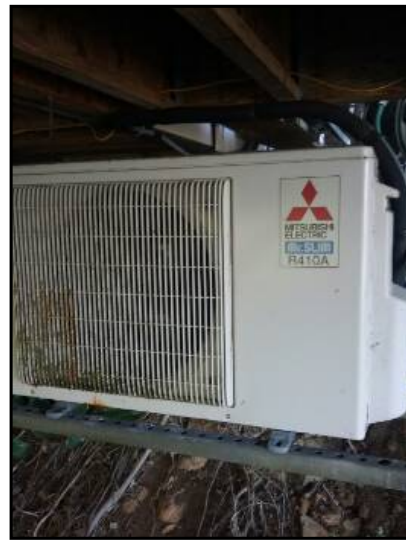
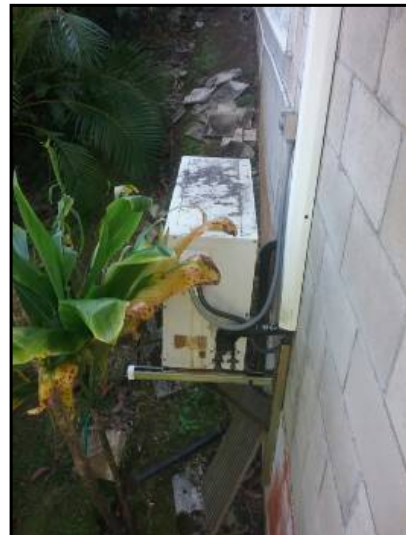
7. AC Compress Condition

Recommend sealing around protrusions from a/c lines

- Annual HVAC service contract is recommended.

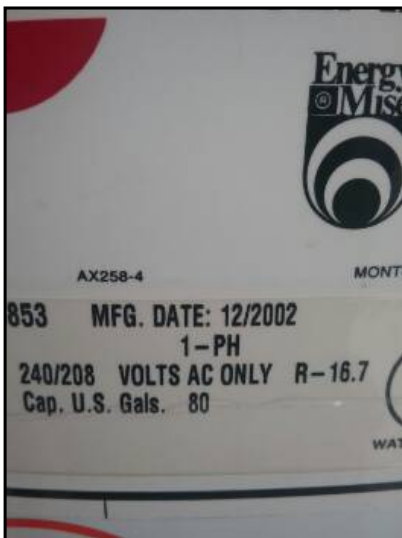
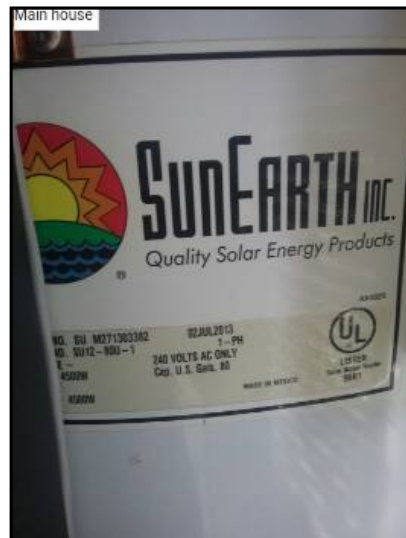
5. Water Heater Condition

- Water heater is reaching the end of its typical service life. Highly recommend replacement.

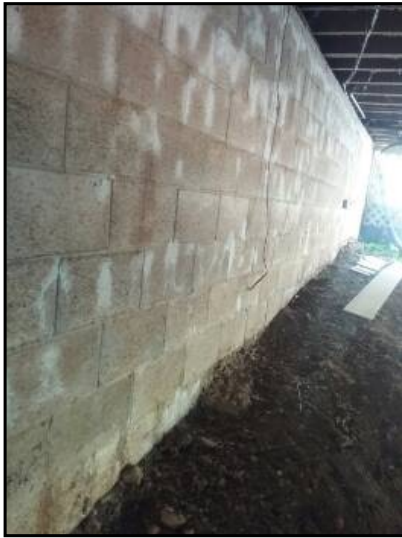
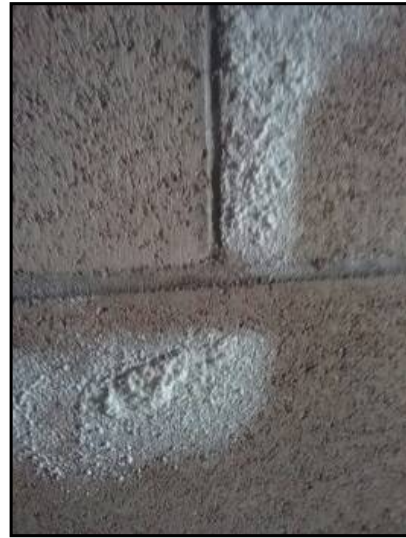
3. Foundation Walls

- Normal settlement.
- Efflorescence observed; this is a mineral deposit left behind from exterior water infiltration.

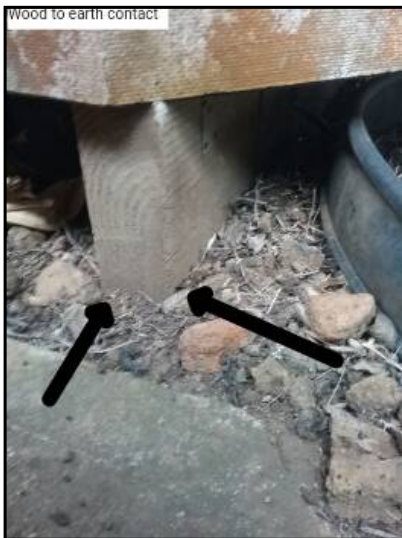
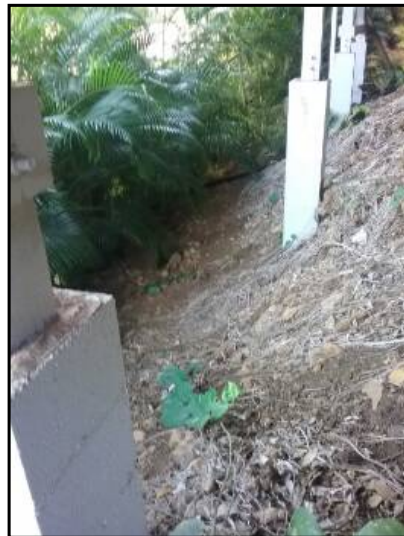
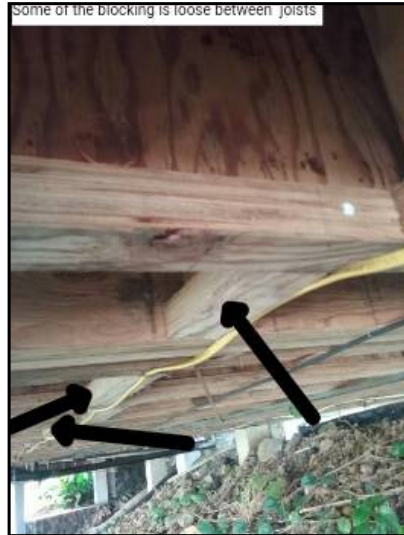
- Support Material: concrete block piers
- Support Material: Block Pillars
- Beam Material: Wood
- No deficiencies were observed at the visible portions of the structural components of the home other than those noted
- Some beams are sitting directly in soil.
- Vegetation growing through floor joists (see pics)
- Some blocking are loose between joists

Some of the blocking is loose between joists

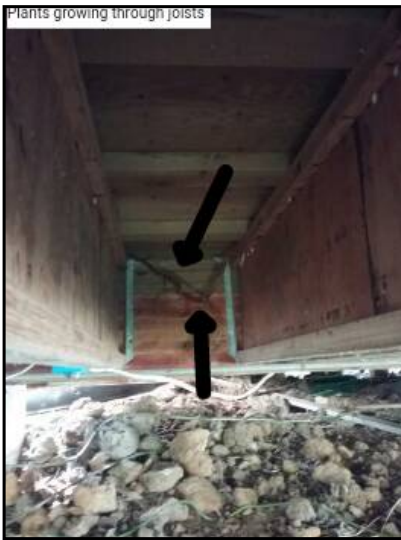
Plants growing through joists

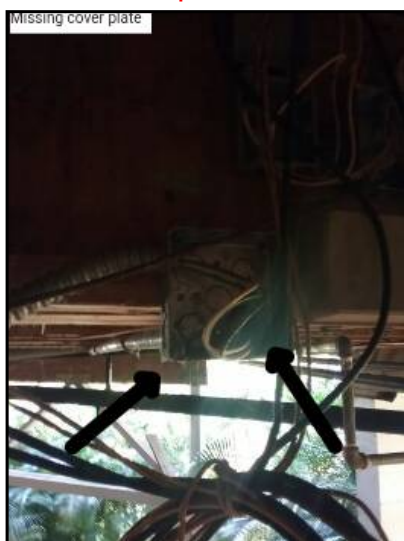
11. Foundation Electrical

Observations:
 • All wiring should be properly secured to the framing.
 • Exposed electrical wiring observed. This is a safety concern if used where it could be subject to "Physical Damage". Exposed electrical wires are normally encased in conduit to ensure safety. Client should consult with a licensed electrician prior to closing for repairs/replacement as needed to ensure safety.
 • Open junction boxes were observed. Whenever an electric wire is cut and reconnected, the 'splice' should be encased in a covered junction box to prevent shocks and separation of the splice.

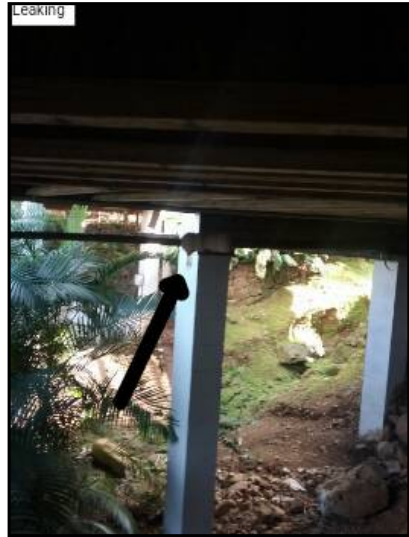
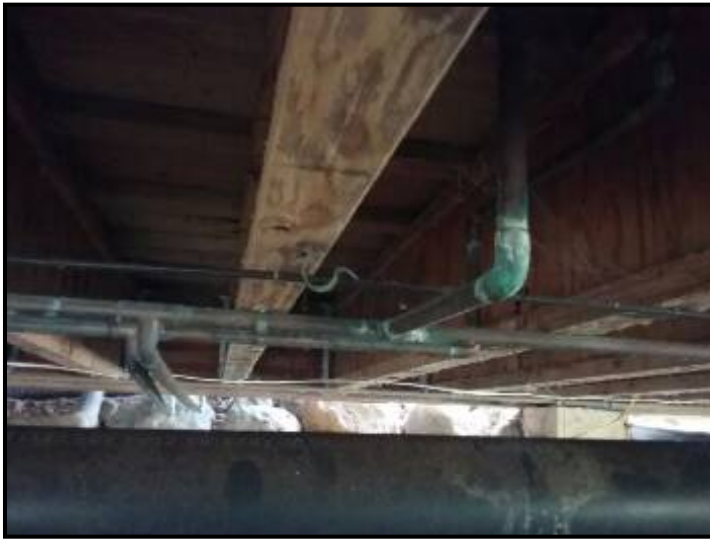
12. Foundation Plumbing

Observations:
 • 3/4 inch copper
 • Acrylonitrile-Butadiene-Stryrene "**ABS**" waste and vent pipes noted.
 • Appears Functional at time of inspection.
 • 1/4 water line leaking

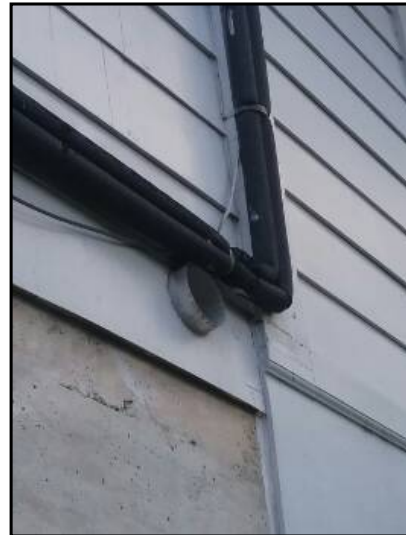
- The dryer vent is missing the exterior cover.

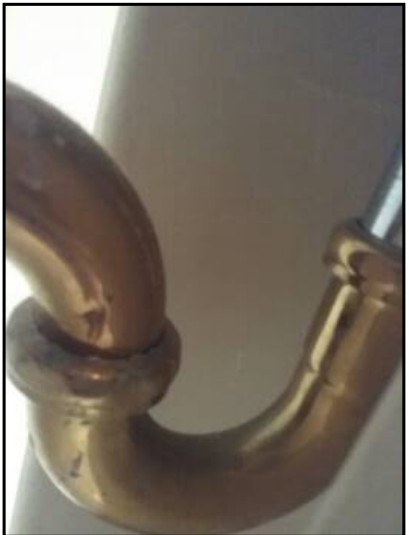
- Older style metal traps noted. Buyer is cautioned that these traps can leak at any time due to corrosion.

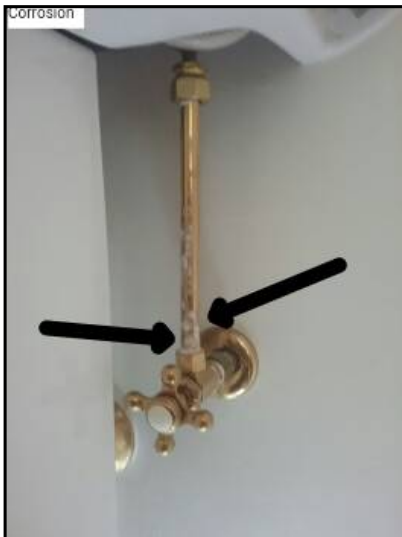
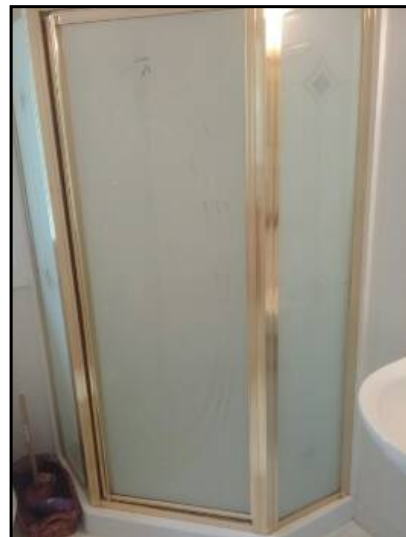
- Supply line showing signs of corrosion
